TECHNICAL REPORT HL-83-21

NAWILIWILI BREAKWATER STABILITY STUDY NAWILIWILI HARBOR, KAUAI, HAWAII

Hydraulic Model Investigation

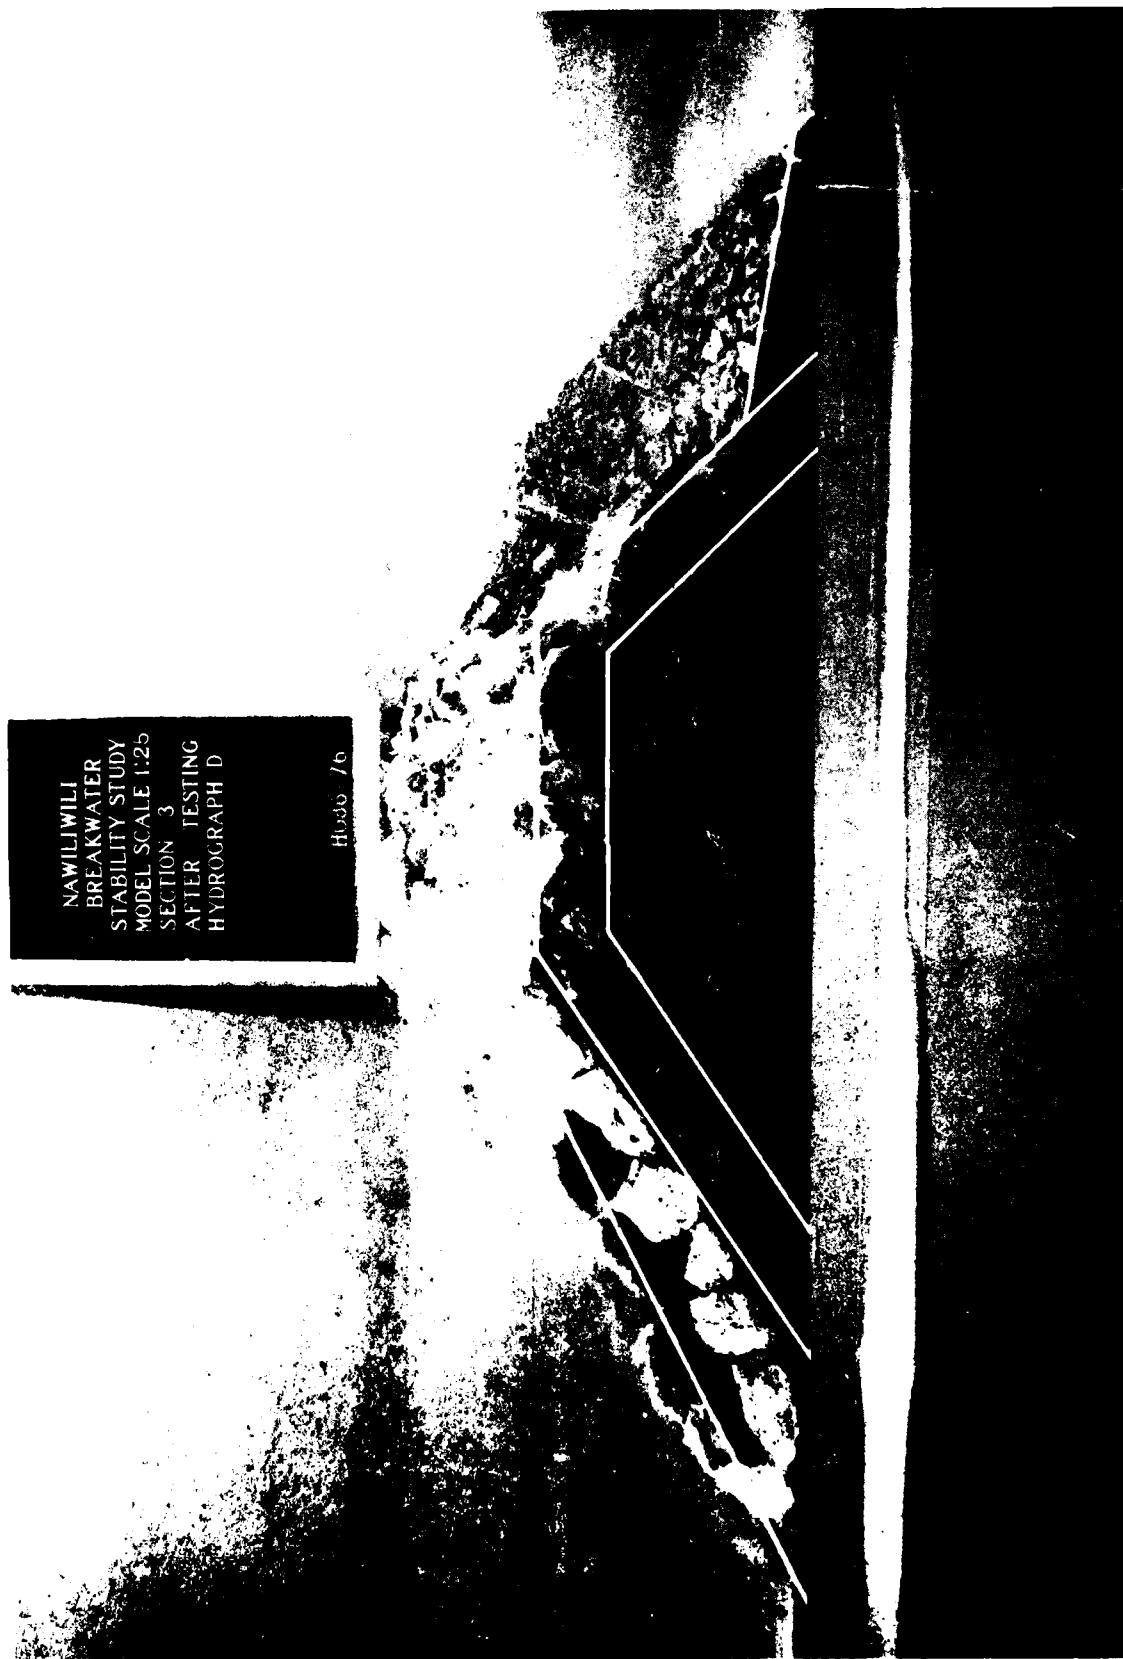
damage during its exposure to Hydrograph III (Photos 29-31). The only movement observed was minor in-place rocking of four to six armor stone on the lower sea-side slope. Steps 1 and 2 of Hydrograph III produced minor to moderate amounts of splash over the structure crown, while Step 3 produced very minor amounts of solid water overtopping.

Photo 29. Side view of Section 3 after testing

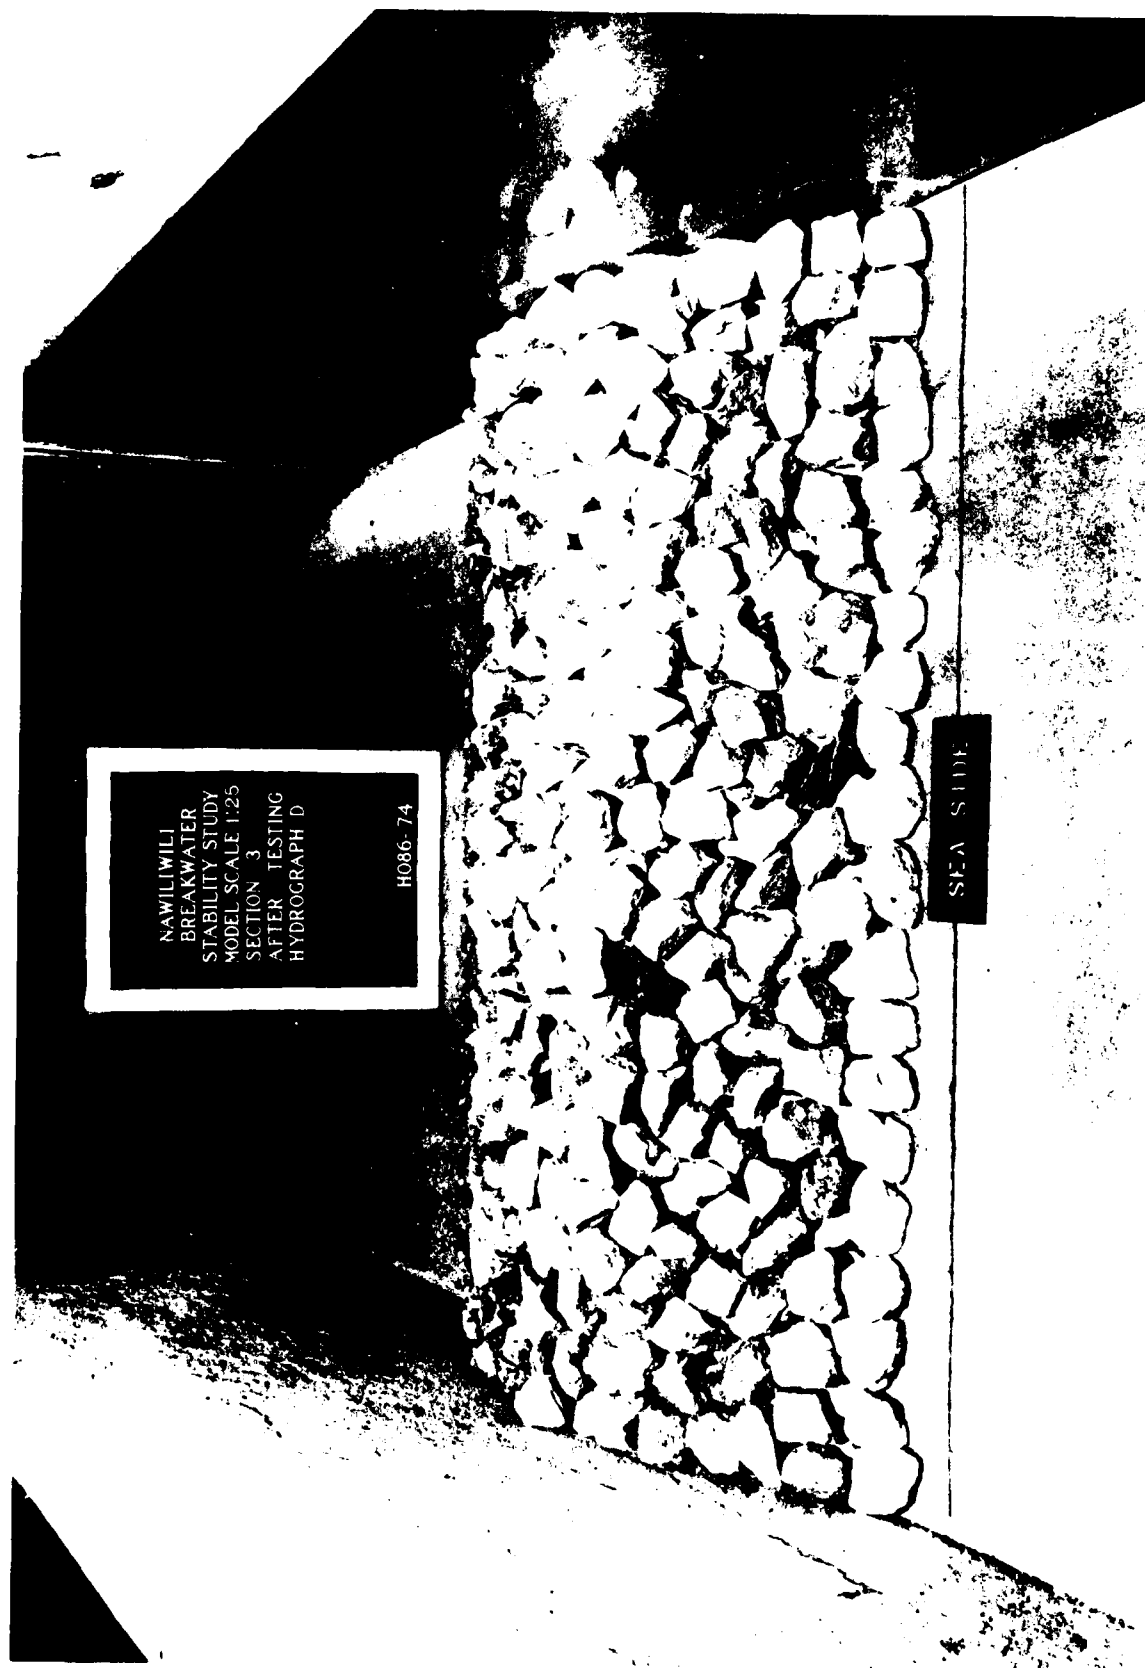
Photo 30. Sea-side view of Section 3 after testing

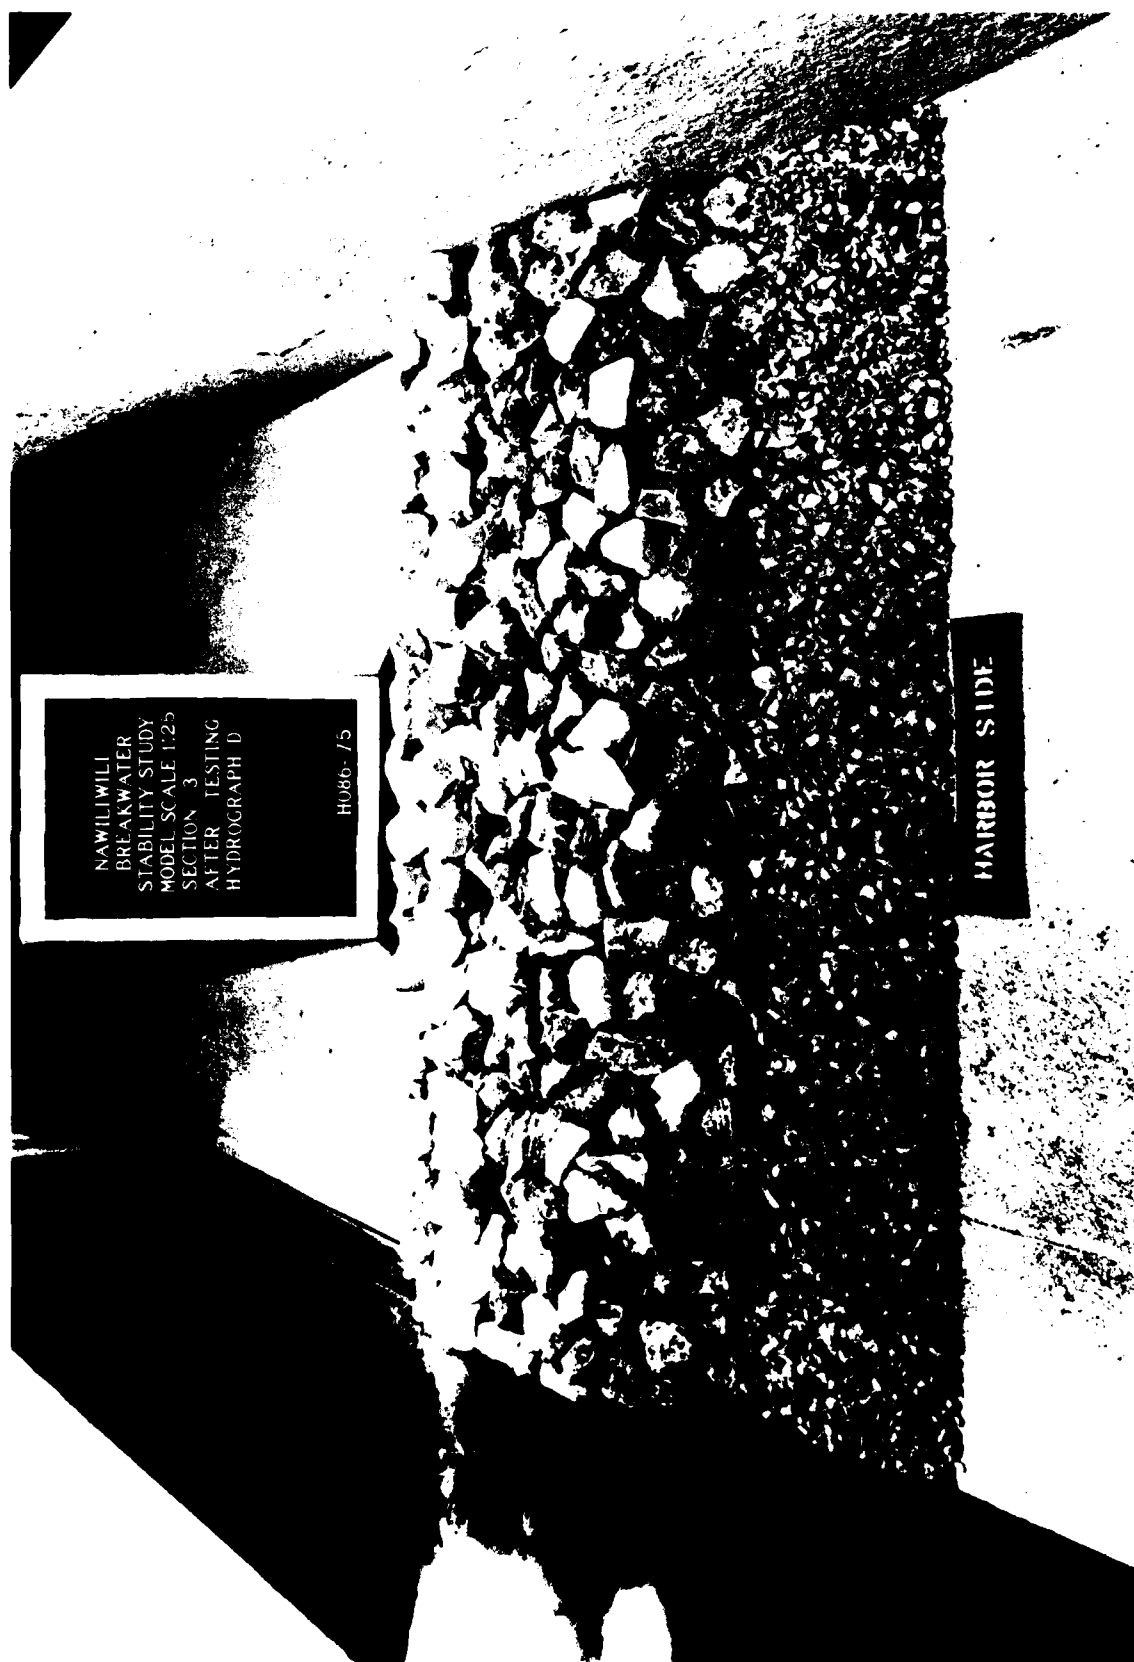
Photo 31. Harbor-side view of Section 3 after testing
